# MOTORCYCLE IMPACTS TO ROADSIDE BARRIERS – REAL-WORLD ACCIDENT STUDIES, CRASH TESTS AND SIMULATIONS CARRIED OUT IN GERMANY AND AUSTRALIA

DEKRA Automobil GmbH

Monash University

Paper Number 05-0095

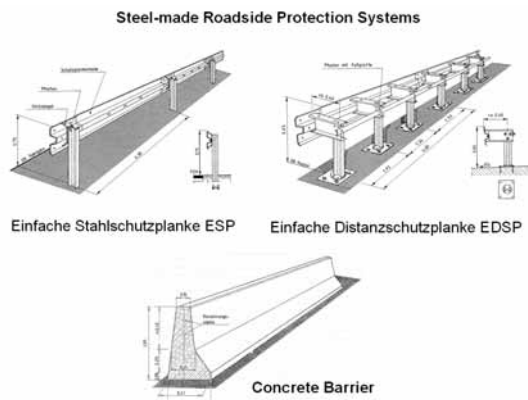
**Figure 1. Two steel-guard rails and a concrete barrier common for German roads and investigated with full-scale crash tests**

63% of the 57 cases analysed by DEKRA involved a steel barrier “Einfache Stahlschutzplanke” ESP (Figure 1.). The second most frequently struck barrier, comprising 18% of all such crashes was another steel-made system, the so called “Einfache Distanzschutzplanke” EDSP (Figure 1.).

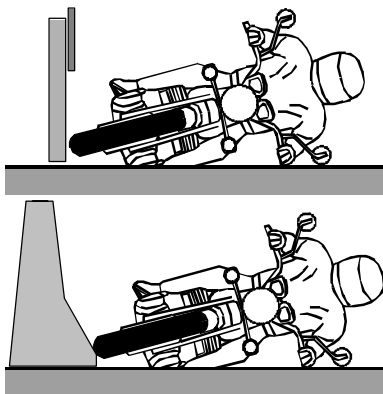
**Figure 4.** Test where the motorcycle impacted the barrier skidding on its side

Two impact scenarios were chosen for the full-scale crash test program as a result of the findings from the real-world crash study. In the first impact scenario the motorcycle was driven in an upright position (Figure 3) prior to impact. In the other scenario the motorcycle struck the barrier while skidding on its side (Figure 4).

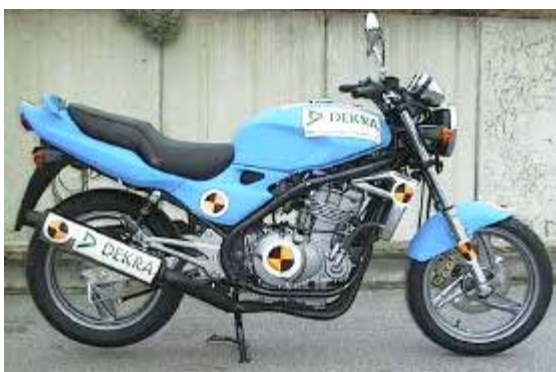
All tests were carried out with the same make, model and type of motorcycle being a Kawasaki ER 5 Twister (Figure 5.). The mass of the motorcycle itself was approx. 180 kg and approx. 272 kg with the dummy sitting on the motorcycle and wearing standard protective clothing.

**Figure 5.** Motorcycle Kawasaki ER 5 Twister as used for all crash tests

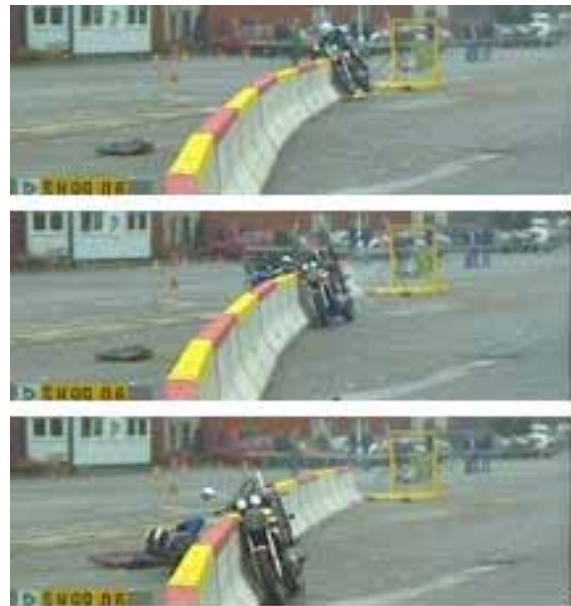
The concrete barrier (Figure 8) does not have any aggressive open shaped parts as in the case of the steel-based systems. In this crash test the motorcycle left the sled at 60 km/h prior to impacting the barrier. This was followed by the dummy flying over the top of the barrier. The dummy reached its final rest position on the opposite side of the barrier (Figure 8 and Figure 9). The distance of the final rest position from the point of first contact primary impact location was 26 m for the dummy and 38 m for the motorcycle.

**Figure 8. Full-scale crash test of a motorcycle impacting a concrete barrier protection system in an upright position prior to impact moving**

The measured dummy loads again do not indicate any life-threatening injury risk (see Table 2.). The right femur is subjected to a compressive load of 4.5 kN being clearly below the injury limit of 10 kN.

Analysis of the film revealed that the motorcycle and the rider were effectively not decelerated during contact with the concrete barrier. As a consequence of this the risk of being deflected by the barrier into oncoming-traffic on the road is clearly higher than for a barrier protection system made from steel. Another disadvantage of concrete barriers is that during an impact they do not dissipate as much kinetic energy via deformation as the systems made from steel.

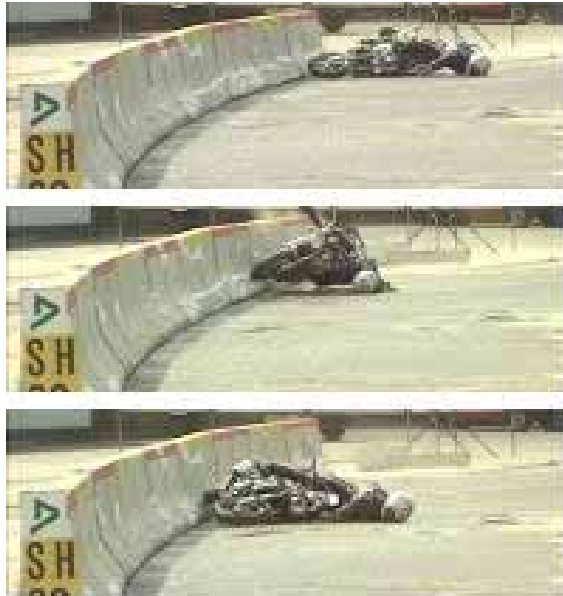
The impact where the motorcycle slides onto its side into the concrete barrier is shown in Figure 12. The motorcycle left the sled at 59 km/h and the front wheel impacted the barrier at 46 km/h.

**Figure 12. Full-scale crash test where the motorcycle impacts the concrete barrier protection system in a sliding position**

Deceleration of the motorcycle and dummy were not as rapid as during the impact where the motorcycle slid into the guard rail made from steel. Nevertheless the measured dummy decelerations for the primary impact were high, indicating a risks of severe and life-threatening injuries. The dummy head loads again lay clearly above the corresponding biomechanical limits.

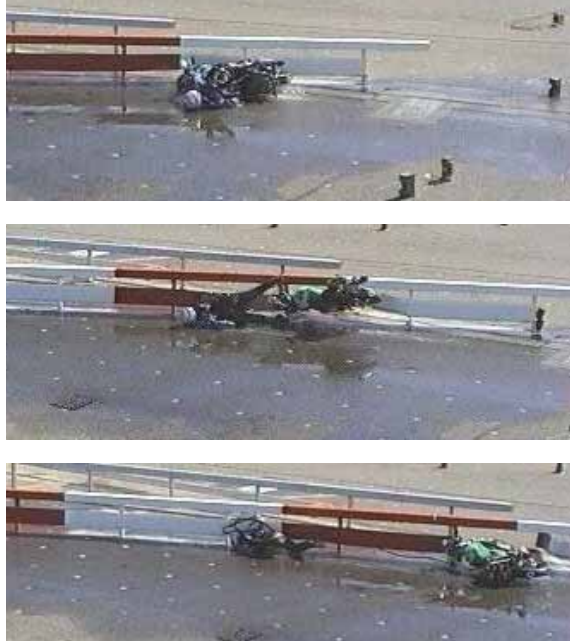
Figure 17 shows the crash test where the motorcycle and dummy slides on the road surface. The motorcycle left the sled at 60 km/h and impacted the barrier at 54 km/h. Due to the impact the underrun protection board broke and the motorcycle struck a Sigma post. The dummy separated from the motorcycle immediately after the initial primary impact and then the helmeted head struck the underrun protection board.

**Figure 17. Full-scale crash test where the sliding motorcycle impacted the modified steel guard rail system**

Table 6 gives an overview of measured dummy loads related to the primary impact and to the secondary impact. For the primary impact into the protection system all measured dummy loads were clearly less than their corresponding injury tolerance limits. However the measured 3-ms-96 g head acceleration during the secondary impact is above the tolerance limit of 80 g. Also the HIC in the secondary impact with a value of 510 but clearly beneath the limit of 1,000 is relatively severe.

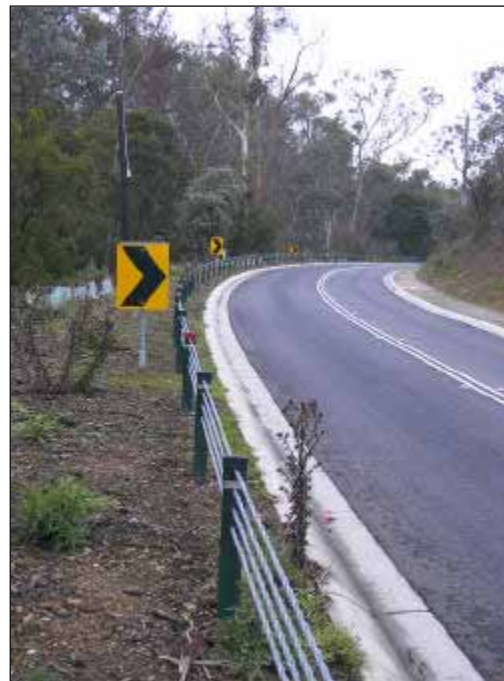
The wire rope barrier model was based on an actual installed system (Figure 20 and Figure 21). This barrier consisted of seven posts that supported the four wires of the barrier. The wires of the barrier that were modelled are made up of three high tensile steel cables woven together with an assumed yield stress of 500 MPa. They have a combined circumference of 60 mm and were represented in the model by a TRUSS2 finite element with a cross sectional area of 280 mm<sup>2</sup> for each cable. The wires had an initial tension setting of 5 kN. Ellipsoids were used to model the support posts being 2 mm thick.

**Figure 20 Four rope wire rope barrier**

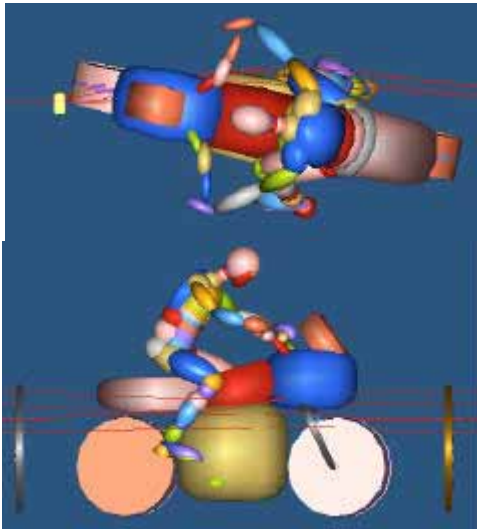
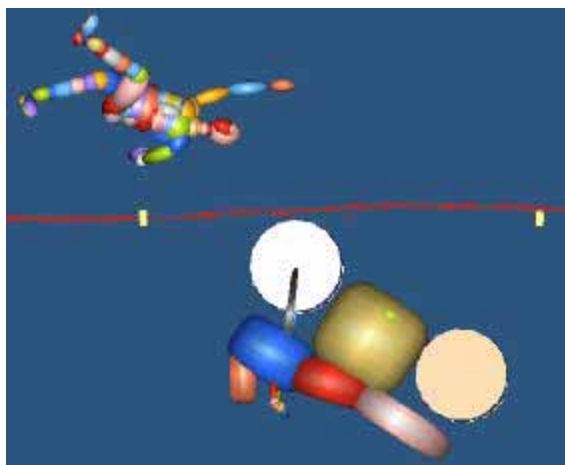
Figure 23 MADYMO simulation showing an upright seated rider on a motorcycle crashing into a wire rope barrier at 60 km/h and 12°

Figure 23 shows the kinematics for an upright rider on a motorcycle impacting a wire rope barrier. The calculated injuries from the simulations suggest that serious injury would result regardless of speed and impact angle.

In all simulations the motorcycle slides along the wires until it hits a post, squeezing and trapping the rider's leg against the wires as it does so. The post contact causes the motorcycle's front wheel to snag lifting the front of the motorcycle up and throwing the rider's torso and head forward. Because the rider's leg is trapped between the motorcycle and the wire ropes and the foot snags in the ropes, the head and torso slap into the front of the rising motorcycle. Eventually the leg becomes free as the motorcycle rotates and the rider is then catapulted over the barrier. This is a different result to the concrete barrier where the rider was thrown over the barrier with relatively little snagging or deceleration.

In both the 60 km/h and 80 km/h impact speeds at an angle of 25°, the motorbike throws the rider into the air with the rider hitting the ground head first. Hence the high HIC.
